SUPPLEMENTARY INFORMATION
Photos of Existing Site

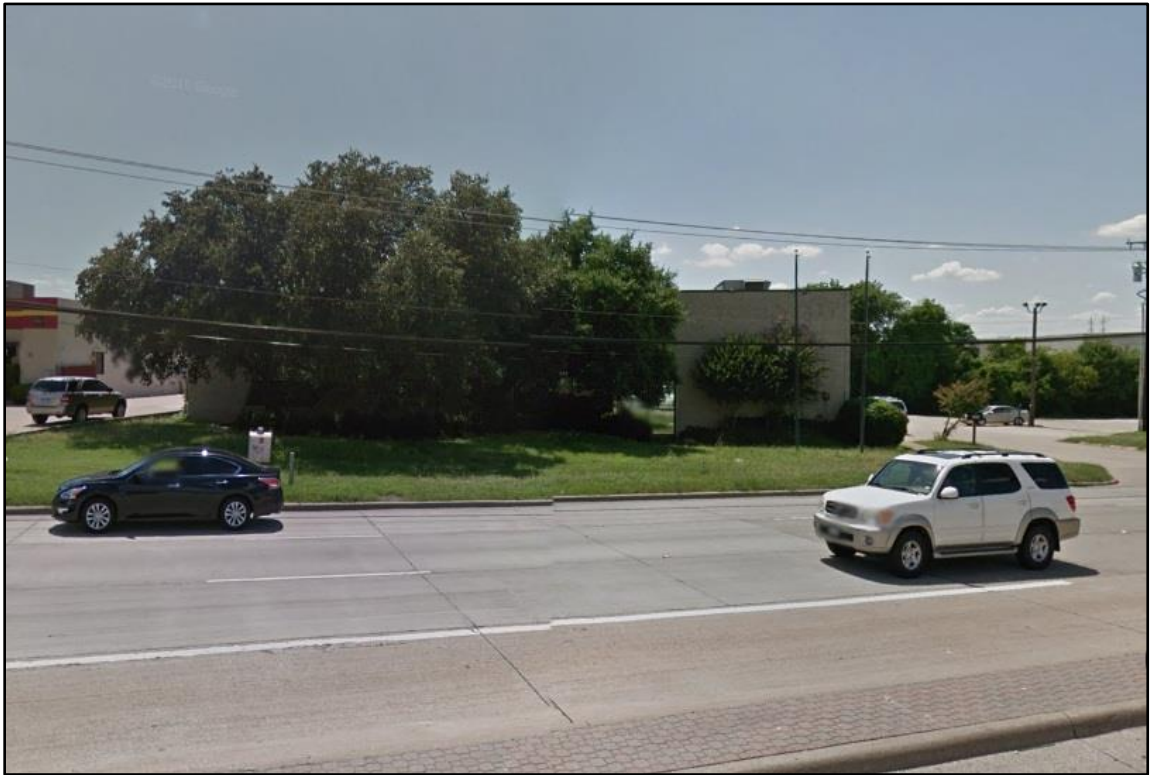
Above: East Façade – Note Existing Mature Trees To Be Retained

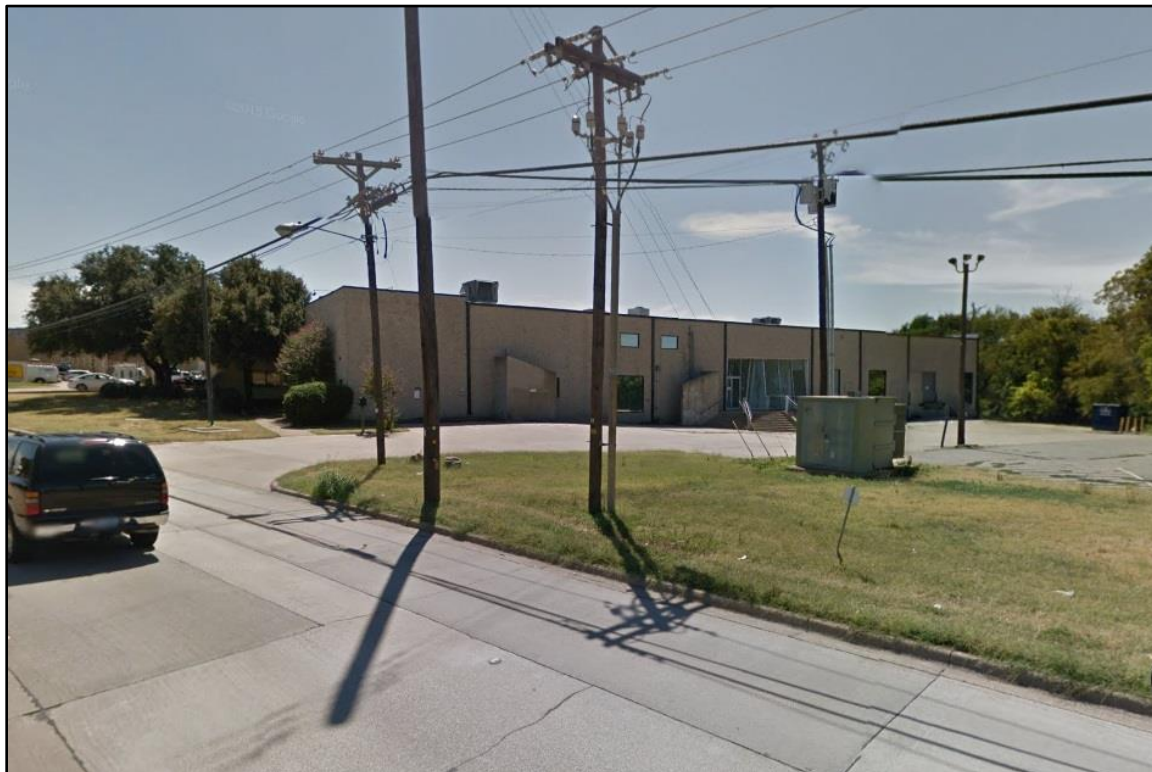
Below: North Façade – Note Rooftop Equipment

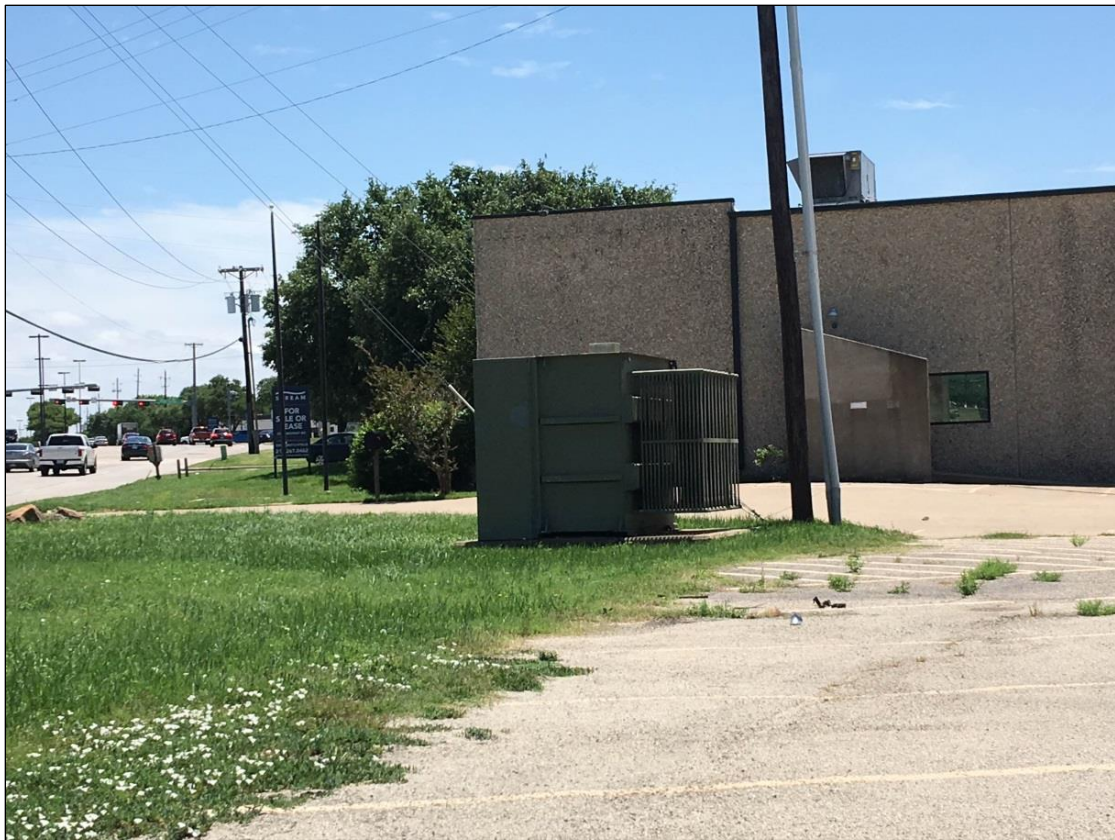
View of Utility Generator – Lack of Landscaping and Screening Along Midway
